TOMASZ ROKITA

Breakdown of hoisting machine in mining shaft hoist installed in southern section of R-II shaft of KGHM Polska Miedź S.A. O/ZG Rudna

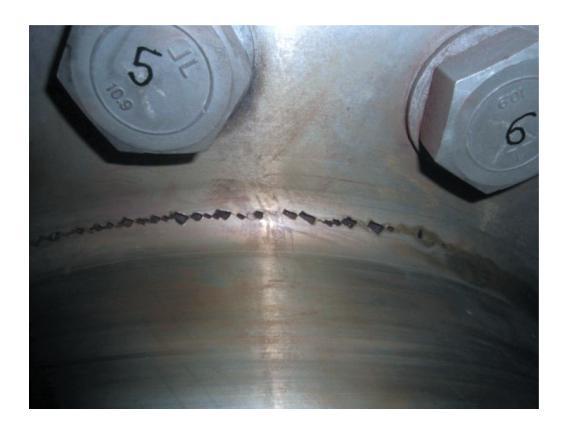
A crack as well as chips of the material in some places were visible along about half of the circumference of the shaft. The nature of the damage indicated fatigue crack (Figs. 2 and 3).

Fig. 2. Cracks in circumference with crushing [1]

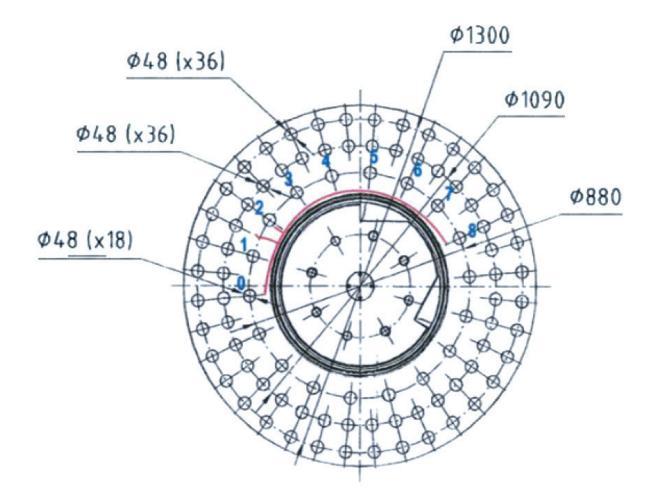
Fig. 4. Side disc of hoist drum of hoisting machine in southern section (eastern side) with cracks marked (red) [2]

- a crack on the circumference ~ 1000 mm long in the axial direction (in parallel to the axle of the shaft) through the material,
- a crack with some crushing of the material ~ 460 mm long in the axial direction through the material,
- two radial cracks (perpendicular to the axle of the shaft) from the circumference ~ 100 mm long and ~ 60 mm between the Bolts 1 and 2.

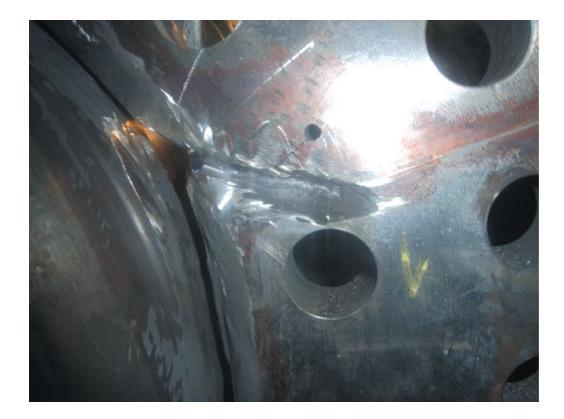
Fig. 5. The repair. Preparation of weld groove with view on depth of flange and size of crack [1]

The decision was made to repair the cracked shaft by welding in accordance with the technology developed by the Institute of Welding in Gliwice and agreed with by ZG Rudna [4]. Due to the vast loss of the material of the flange, the preparation of a weld groove was necessary; that is, the execution of the appropriate undercuts (geometry) of the connected elements (Fig. 5). After the appropriate preparation of the edges of the weld groove, penetration tests were conducted (to detect any cracks).

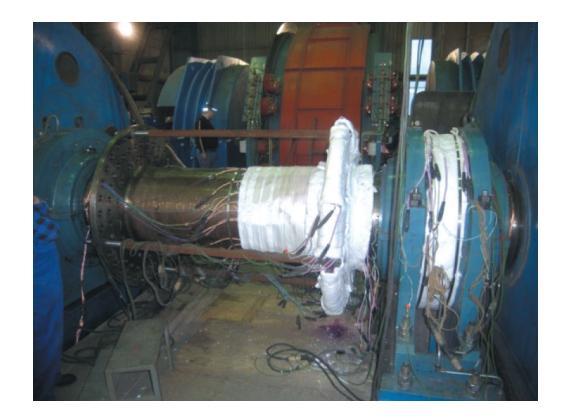
Fig. 6. Area around place of welding was isolated and then heated up with electric heating unit and heating mats. Heating speed was about 25°C/h [1]

The area around the site of the repair was isolated and then heated up to a temperature of ca. 100°C with an electric heating unit and heating mats ata rate of about 25°C/h. After stabilizing the temperature on the shaft and the flange, the welding work was started while at the same time continuously recording the temperature of the elements neighboring the site of the welding (Fig. 6). Special attention was paid to maintaining the difference of the temperatures of the elements of the bearing supporting the shaft within the proper range [5–7].

To protect the rolling bearing against possible damage as a result of thermal expansion, the bearing case was heated up so that the temperature difference between the internal and external races would not exceed 15°C.

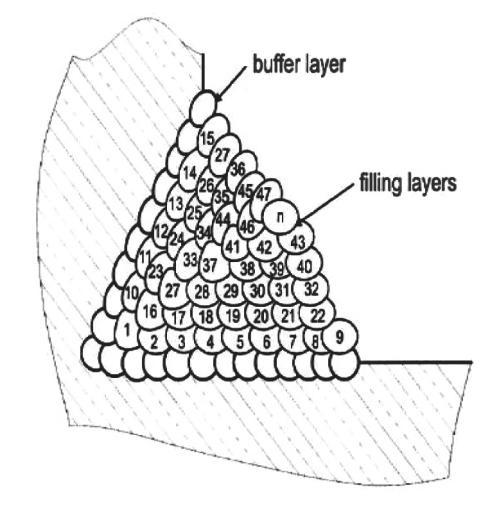
Fig. 7. Order of execution of welding work: buffer layer and filler layer [4]

Due to the fact that the material of the shaft is made of steel with highly difficult weldability (as well as considering the scope of the damage), the welding process was done in two stages. First, the buffer layer was done on the side of the shaft and of the flange. Then, the surface of the buffer layer was properly smoothened by grinding, and the weld groove was started in accordance with the prepared instruction (Fig. 7). Figure 8 presents a view of the part of the shaft in the area of the crack after applying the buffer layer.

The next stage was connecting the flange to the shaft (closing the weld). An ENiCrFe-3 wire was used as a binder according to AWS A 5.11. After connecting the flange with the shaft, the whole weld groove was filled in along with the machining allowance (Fig. 9).

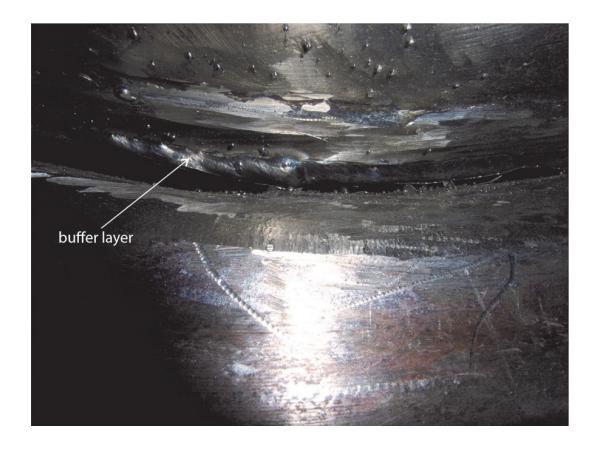
Fig. 8. View of shaft after applying buffer layer [1]

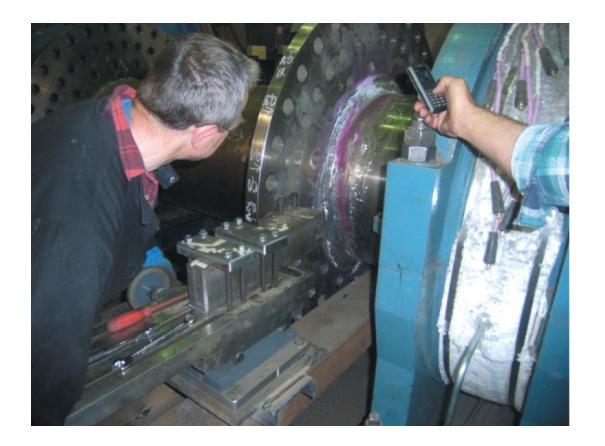
Fig. 9. Machining of shaft after welding to render proper curvature radius for part of shaft [1]

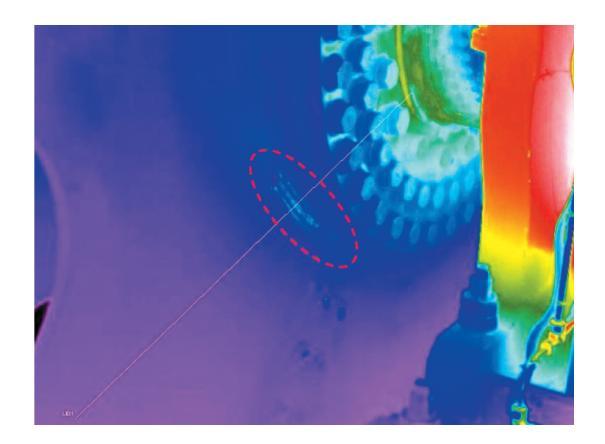
Fig. 10. Thermogram of part of drive shaft and of disk of drive wheel from southeastern side ("rain" pallet) [10]

The thermovision measurements showed a lack of significant temperature differences of the analyzed driving structure (the shaft – the hoist drum). No major

differences were recorded against the measurements before the breakdown. The average temperatures of the shaft in both measurements differed due to the differences in the ambient temperature during the measurements. For this reason, the differences in the temperatures were more important at the passage from the cylinder part of the shaft to the flange to the connection with the hoist drum. The temperature difference was about 5.3°C. One should remember that the measurements could be burdened with measurement uncertainty resulting from the different emissivity factors for the different examined structures, flow of warm and cold masses of air forced by the fans of the motors, vibrations of the tower that may have negatively affected the thermovision camera, effect of the reflection of radiation from other sources of heat, etc.

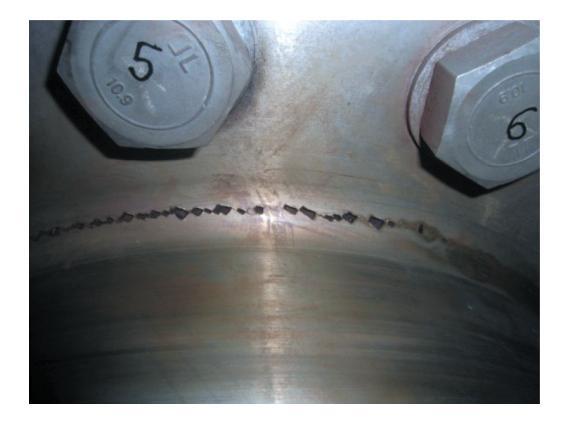
Pęknięcie, jak również miejscami odpryski materiału, były widoczne na długości około połowy obwodu wału. Charakter uszkodzenia wskazywał na pęknięcie zmęczeniowe (rys. 2 i 3).

Rys. 2. Pęknięcia po obwodzie z wykruszeniem [1]

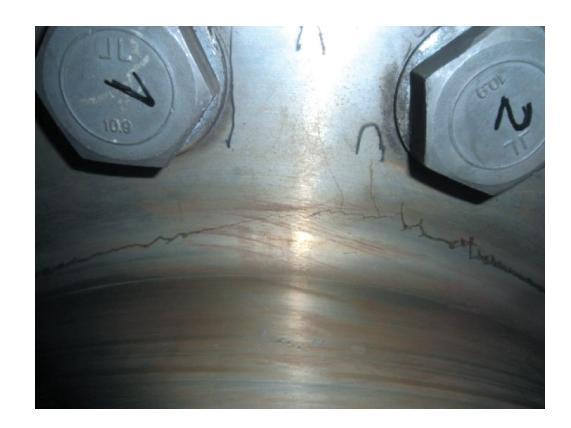
Rys. 3. Pęknięcia po obwodzie oraz pęknięcia promieniowe [1]

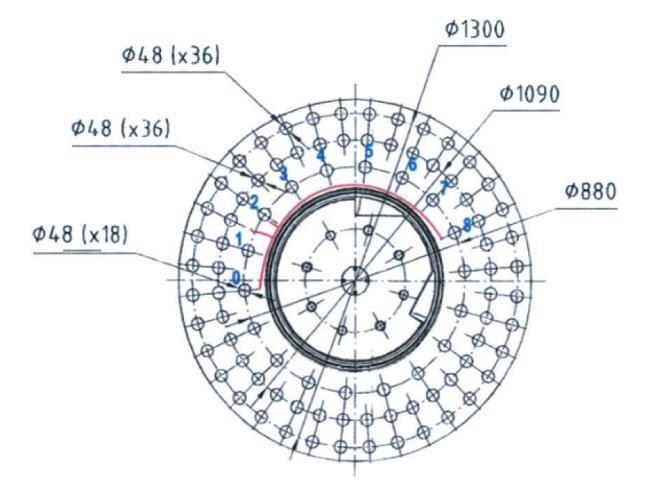
Rys. 4. Tarcza boczna linopędni maszyny wyciągowej w przedziale południowym (od strony wschodniej) z zaznaczonymi pęknięciami (kolor czerwony) [2]

- pęknięcie po obwodzie o długości ~1000 mm w kierunku osiowym (równolegle do osi wału) na wskroś materiału;
- pęknięcie z wykruszeniem materiału o długości ~460 mm w kierunku osiowym na wskroś materiału;
- dwa pęknięcia promieniowe (prostopadle do osi wału) od obwodowego o długości ~100 mm i ~60 mm pomiędzy śrubami nr 1 i 2.

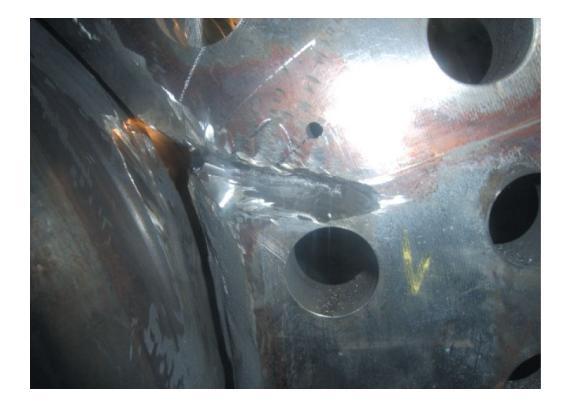
Rys. 5. Przebieg naprawy. Przygotowanie rowka spawalniczego z uwagi na grubość kołnierza i wielkość pęknięcia [1]

Naprawę pękniętego wału zdecydowano się wykonać metodą spawania według technologii opracowanej przez Instytut Spawalnictwa w Gliwicach i uzgodnionej z ZG Rudna [4]. Z uwagi na rozległy ubytek materiału kołnierza konieczne było przygotowanie rowka spawalniczego, czyli wykonanie odpowiednich podcięć (geometrii) elementów łączonych (rys. 5). Po przygotowaniu brzegów rowka spawalniczego przeprowadzono badania penetracyjne (pod kątem wykrycia ewentualnych pęknięć).

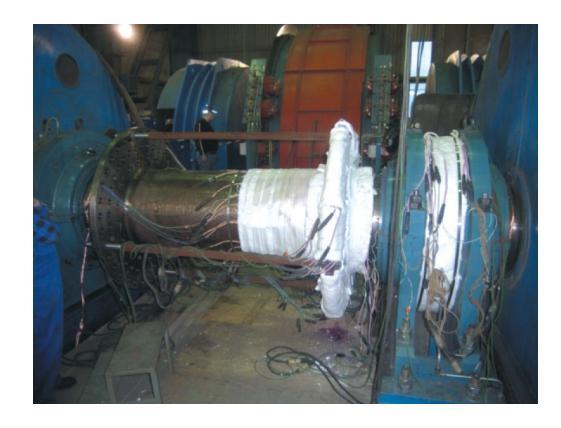
Rys. 6. Obszar wokół miejsca spawania został odizolowany, a następnie podgrzany za pomocą nagrzewarki oporowej oraz mat grzewczych; prędkość nagrzewania wynosiła około 25°C na godzinę [1]

Obszar wokół miejsca naprawy został odizolowany, a następnie podgrzany do temperatury około 100°C za pomocą nagrzewarki oporowej oraz mat grzewczych z szybkością około 25°C na godzinę. Po ustabilizowaniu się temperatury na wale i kołnierzu przystąpiono do wykonywania prac spawalniczych, jednocześnie prowadząc ciągłą rejestrację temperatury elementów sąsiadujących z miejscem spawania (rys. 6). Szczególną uwagę zwracano na utrzymanie w odpowiednim zakresie różnicy temperatur elementów łożyska podtrzymującego wał [5–7].

Aby uchronić łożysko toczne przed możliwym uszkodzeniem wskutek rozszerzalności cieplnej podgrzewano obudowę łożyska tak, aby różnica temperatury między bieżnią wewnętrzną i zewnętrzną nie przekroczyła 15°C.

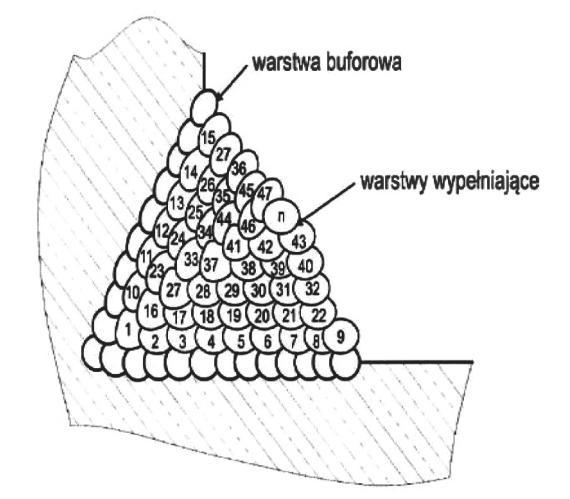
Rys. 7. Kolejność wykonywania prac spawalniczych: warstwy buforowej i warstwy wypełniającej [4]

Ze względu na to, że materiał, z którego wykonano wał, należy do stali trudno spawalnych, a także z uwagi na rozmiar uszkodzenia proces spawania przeprowadzano dwuetapowo. W pierwszej kolejności wykonano warstwę buforową od strony wału oraz kołnierza. Następnie odpowiednio wyrównano powierzchnię warstwy buforowej za pomocą szlifowania oraz przystąpiono do wypełniania rowka spawalniczego zgodnie z przygotowaną wcześniej instrukcją (rys. 7). Na rysunku 8 przedstawiono widok fragmentu wału w rejonie pęknięcia po nałożeniu warstwy buforowej.

Kolejnym etapem było łączenie kołnierza z wałem (zamykanie spoiny). Jako spoiwo wykorzystano drut ENiCrFe-3 według AWS A 5.11. Po połączeniu kołnierza z wałem wypełniono cały rowek spawalniczy oraz nałożono naddatek na obróbkę skrawaniem (rys. 9).

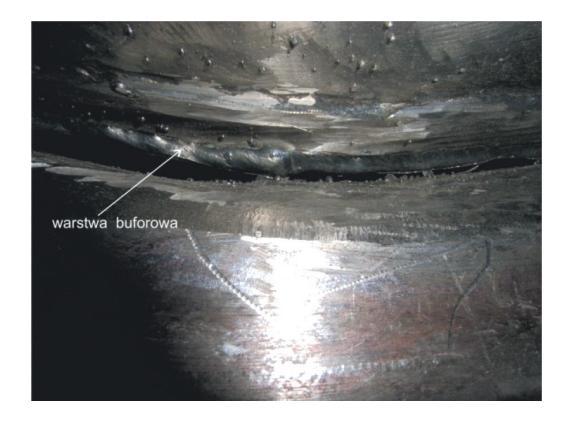
Rys. 8. Widok wału po nałożeniu warstwy buforowej [1]

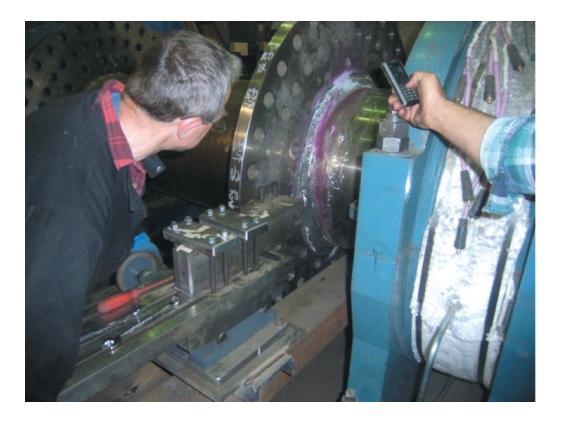
Rys. 9. Obróbka wału po spawaniu w celu nadania fragmentowi wału odpowiedniego promienia krzywizny [1]

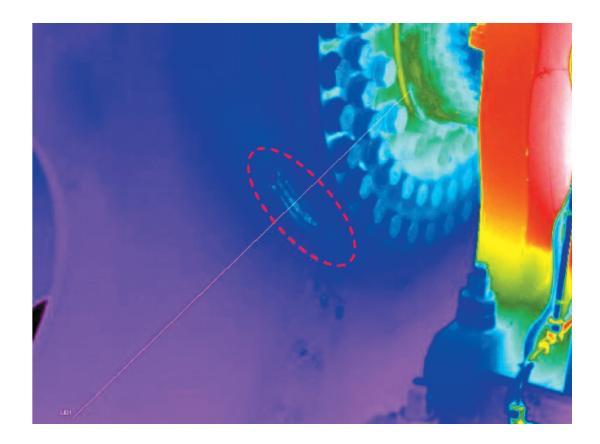
Rys. 10. Termogram fragmentu wału napędowego i tarczy koła pędnego od strony południowo-wschodniej (paleta "rain") [10]

Pomiary termowizyjne wskazały na brak istotnie dużych różnic temperaturowych badanej struktury napędowej (wał – linopędnia). W odniesieniu do wyników pomiarów sprzed awarii też nie zanotowano większych różnic. Średnie temperatury wału obu pomiarów różniły się z powodu różnic w temperaturze otoczenia podczas wykonywania pomiarów. Dlatego ważniejsze były różnice temperatur przy przejściu z części walcowej wału w kołnierz do połączenia z linopędnią. Różnica temperatur wynosiła około 5,3°C. Należy mieć na uwadze to, że pomiary mogły być obarczone niepewnością pomiarową wynikającą między innymi z różnych współczynników emisyjności dla różnych badanych struktur, przepływem ciepłych i zimnych mas powietrza wymuszonym przez wentylatory silników, drganiami wieży mogącymi wpływać niekorzystnie na kamerę termowizyjną, wpływem odbicia promieniowania pochodzącego od innych źródeł ciepła itp.
